STS-27R OV-104 ORBITER TPS DAMAGE REVIEW TEAM

SUMMARY REPORT

VOLUME I

FEBRUARY 1989

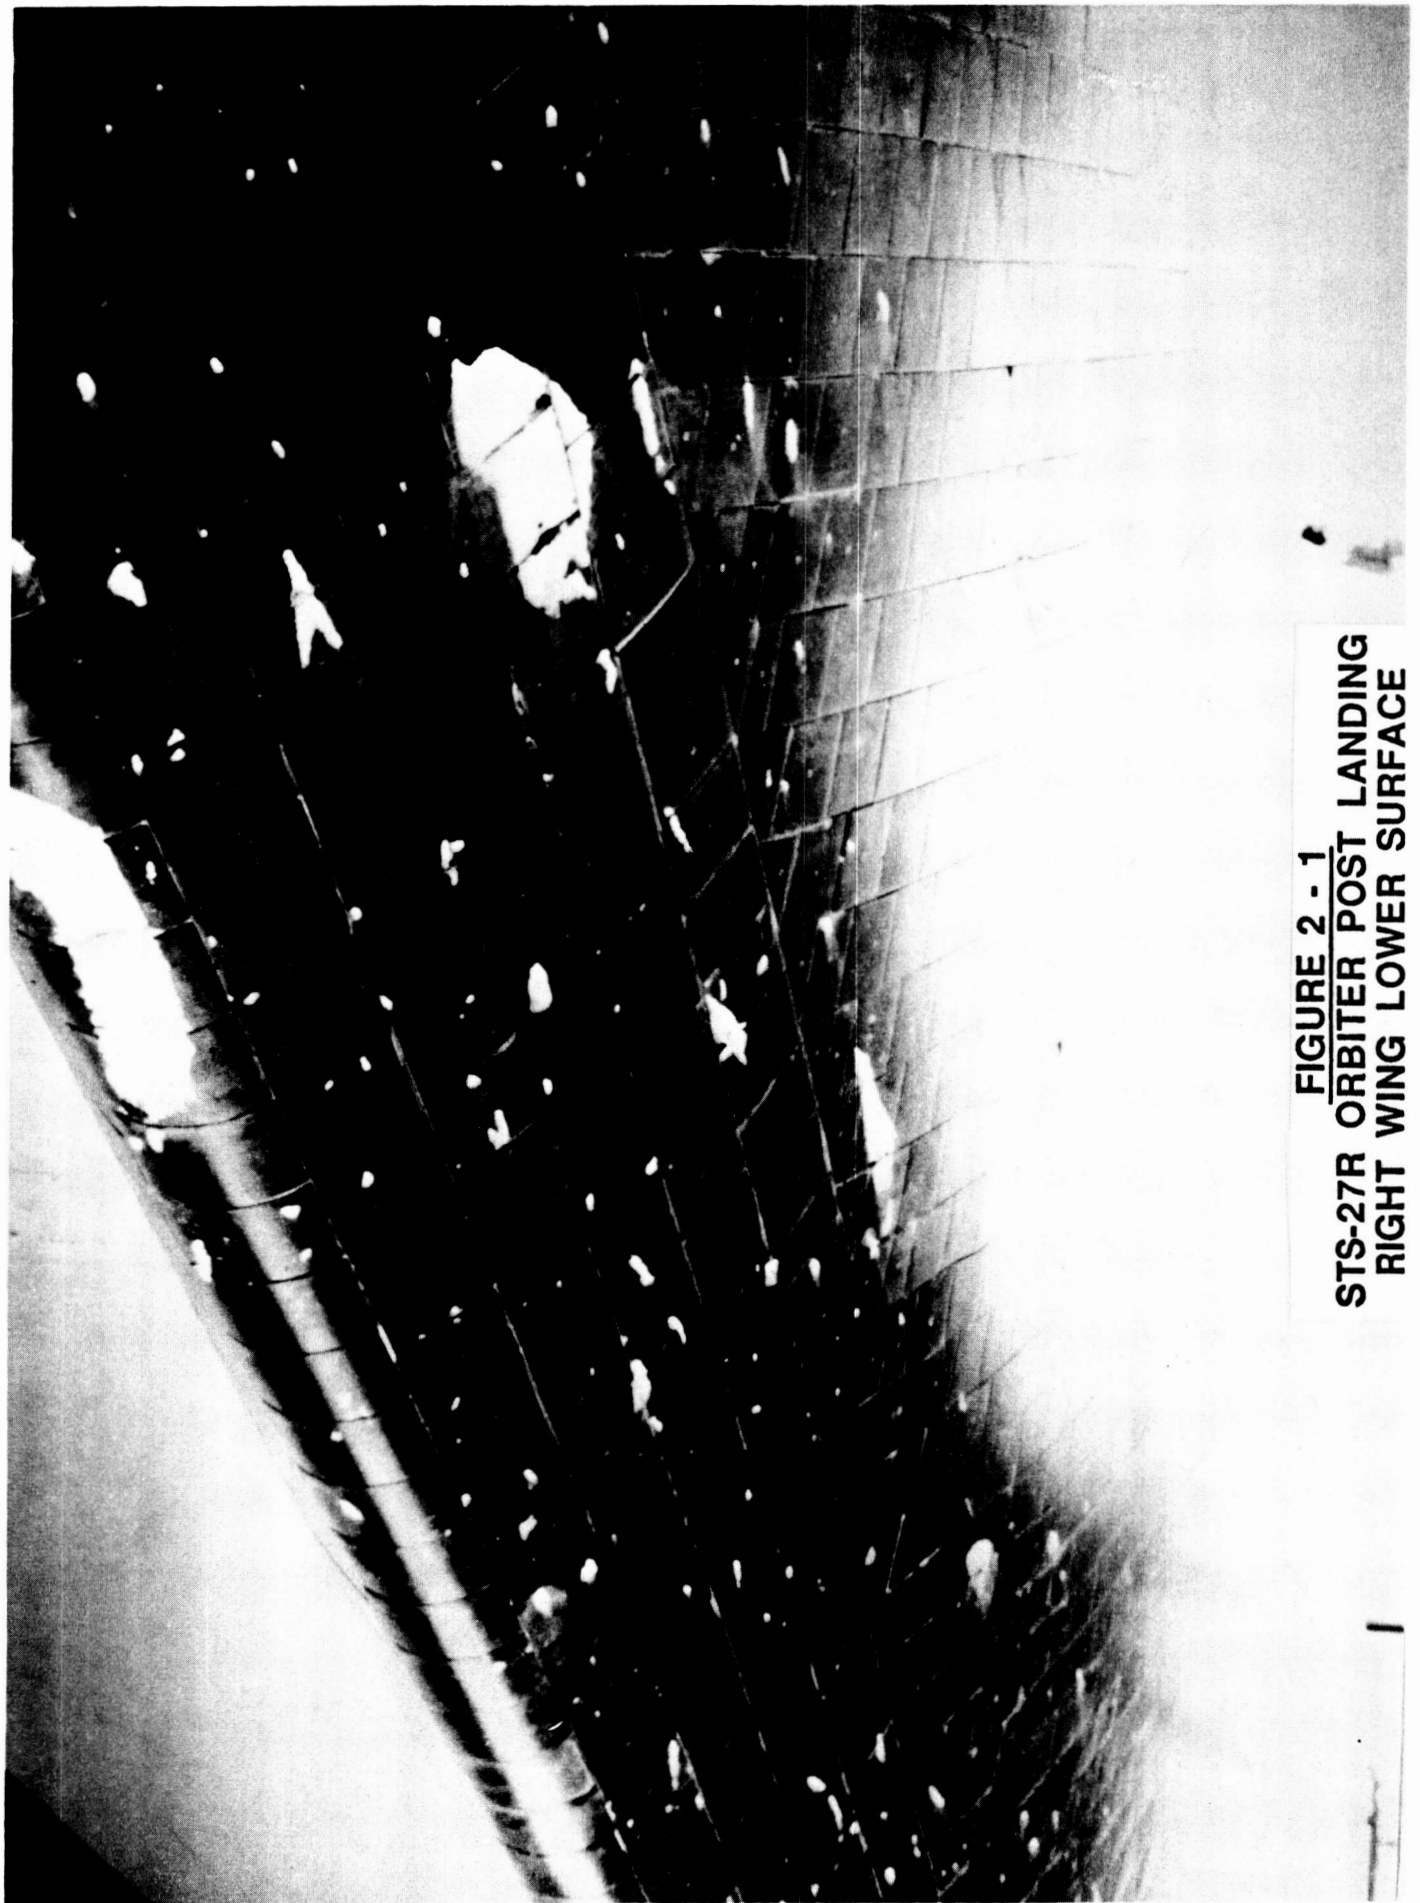
FIGURE 2 - 1
STS-27R ORBITER POST LANDING
RIGHT WING LOWER SURFACE

The Atlantis TPS was inspected at Dryden Flight Research Facility, and also after being ferried back to KSC. While it was at Dryden, the TPS damage was measured, mapped, and recorded. The damage severity and the contrast in right side versus left side damage is readily discernible in Figures 2-1, 2-2, 2-3, and 2-4. The inspection results and damage distribution are as follows:

- a. Total recorded damage sites were 707, with 644 occurring on the lower surface.
- b. Total recorded damage sites with any dimension greater than one inch were 298, with 272 occurring on the lower surface.
- c. The left side had only two damage sites greater than one inch.
- d. The elevon lower surfaces were undamaged.
- e. The right OMS pod had 14 damage sites greater than one inch.
- f. The right rudder speed brake had four damage sites greater than one inch.

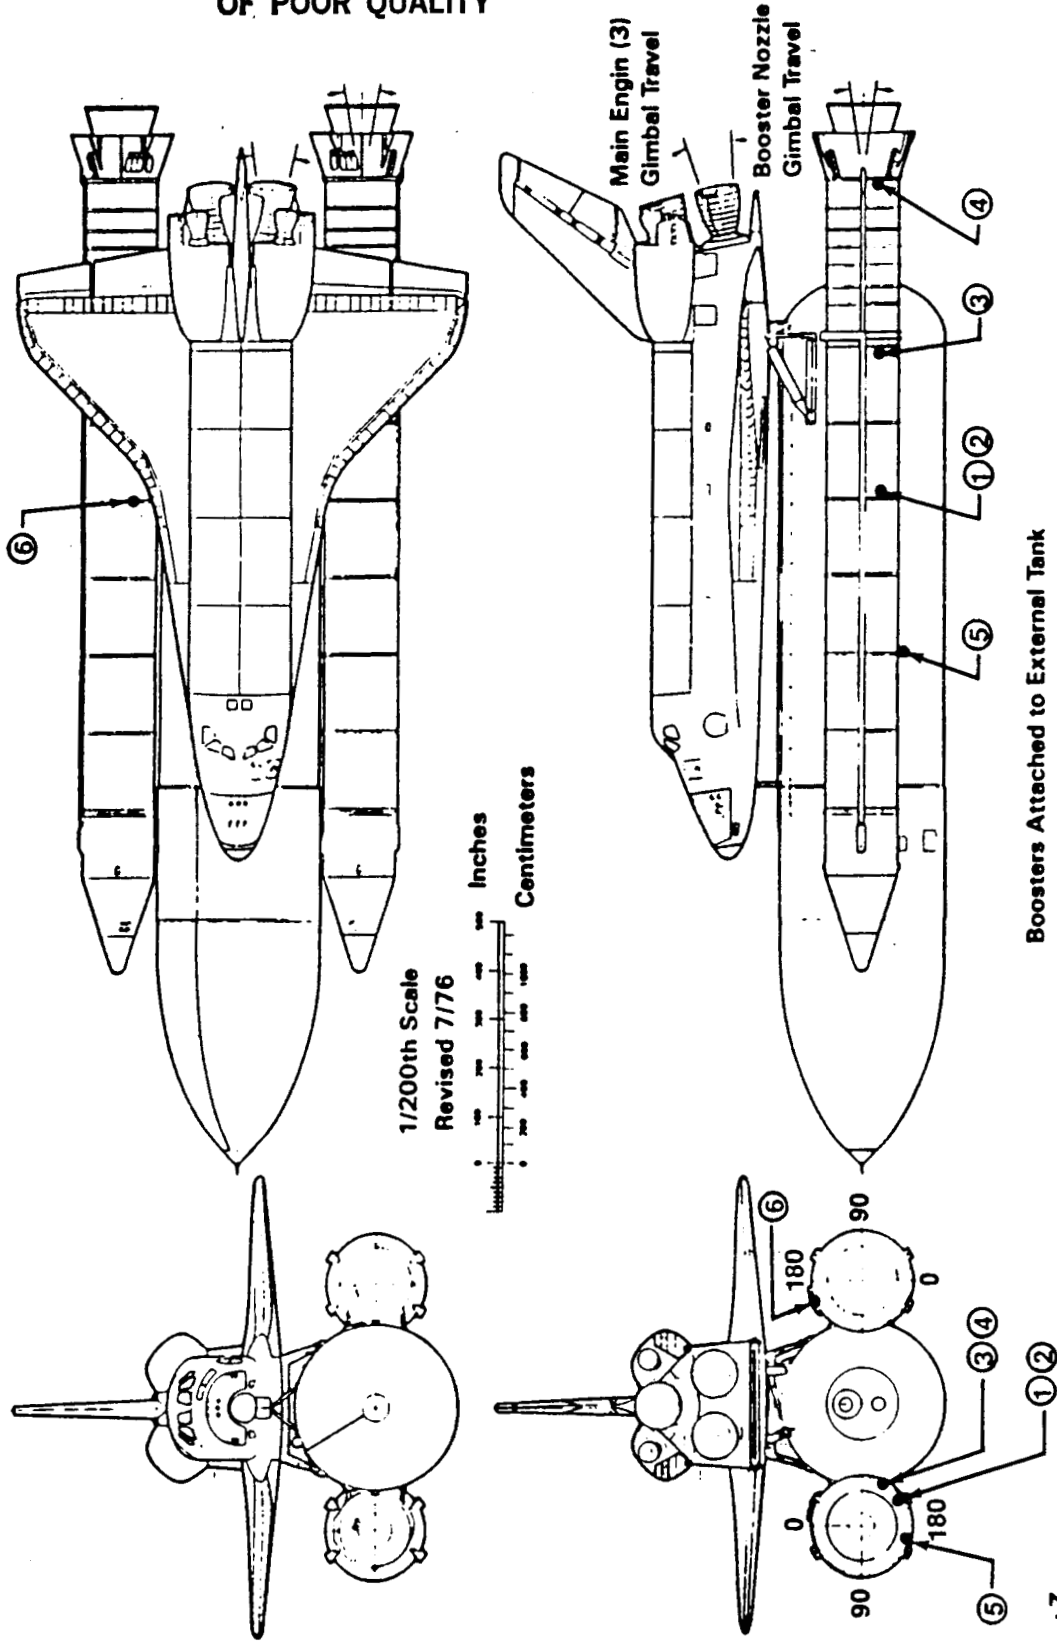
FIGURE 2-7
ORBITER TPS DAMAGE REVIEW TEAM
SRM MISSING CORK

The team reviewed the SRB Post Retrieval Inspection Reports prepared by the SRB Disassembly Inspection Team to ascertain if any debris came from those elements during flight. It was found that four small MSA-1 TPS pieces were missing from the left forward skirt and two pieces were missing from the right forward skirt. There were four small Marshall Trowelable Ablator (MTA)-2 repair material unbonds on the right frustum. Additionally, there were five small SRM Development Flight Instrumentation (DFI) cork pieces missing from the left SRM and one piece of cork missing from the right SRM center joint. The missing material sizes and locations are shown in Table 2-1 and Figure 2-7.

- SRB FORWARD ASSEMBLY (LESS NOSE CAP) MISSING OR DEBONDED MATERIAL
 - LEFT FORWARD SKIRT - MSA 1 - FOUR PIECES AROUND +Y + BETWEEN .15" X .25" AND 1" X 2"
- * ● RIGHT FORWARD SKIRT - MSA 1 - TWO PIECES - AROUND +Y AND +Z - .5" DIA AND 1" X 2"
- RIGHT FRUSTUM - MTA 2 - FOUR PIECES - AROUND +Y - 1/2" TO 1" DIA
- SOLID ROCKET MOTOR - MISSING CORK
 - LEFT MOTOR -
 - ** ① CAP CORK - CENTER JOINT - 244° POSITION - 2.5" X 2"
 - ** ② CAP CORK - CENTER JOINT - 248° POSITION - 3" X 1.5"
 - ** ③ CAP CORK - AFT JOINT - 215° POSITION - 2.5" X 5"
 - ④ CAP CORK - AFT SEGMENT - 218° POSITION - 1" X 5"
 - ⑤ CAP CORK - FORWARD JOINT - 170° POSITION - .75" X .75"
 - RIGHT MOTOR -
 - ⑥ ONE PIECE JOINT PROTECTION CORK-CENTER JOINT - 185° LOCATION - 3.5" X 3.5"
- * HANDLING DAMAGE
- ** IMPACTS FROM NOZZLE SEVERANCE

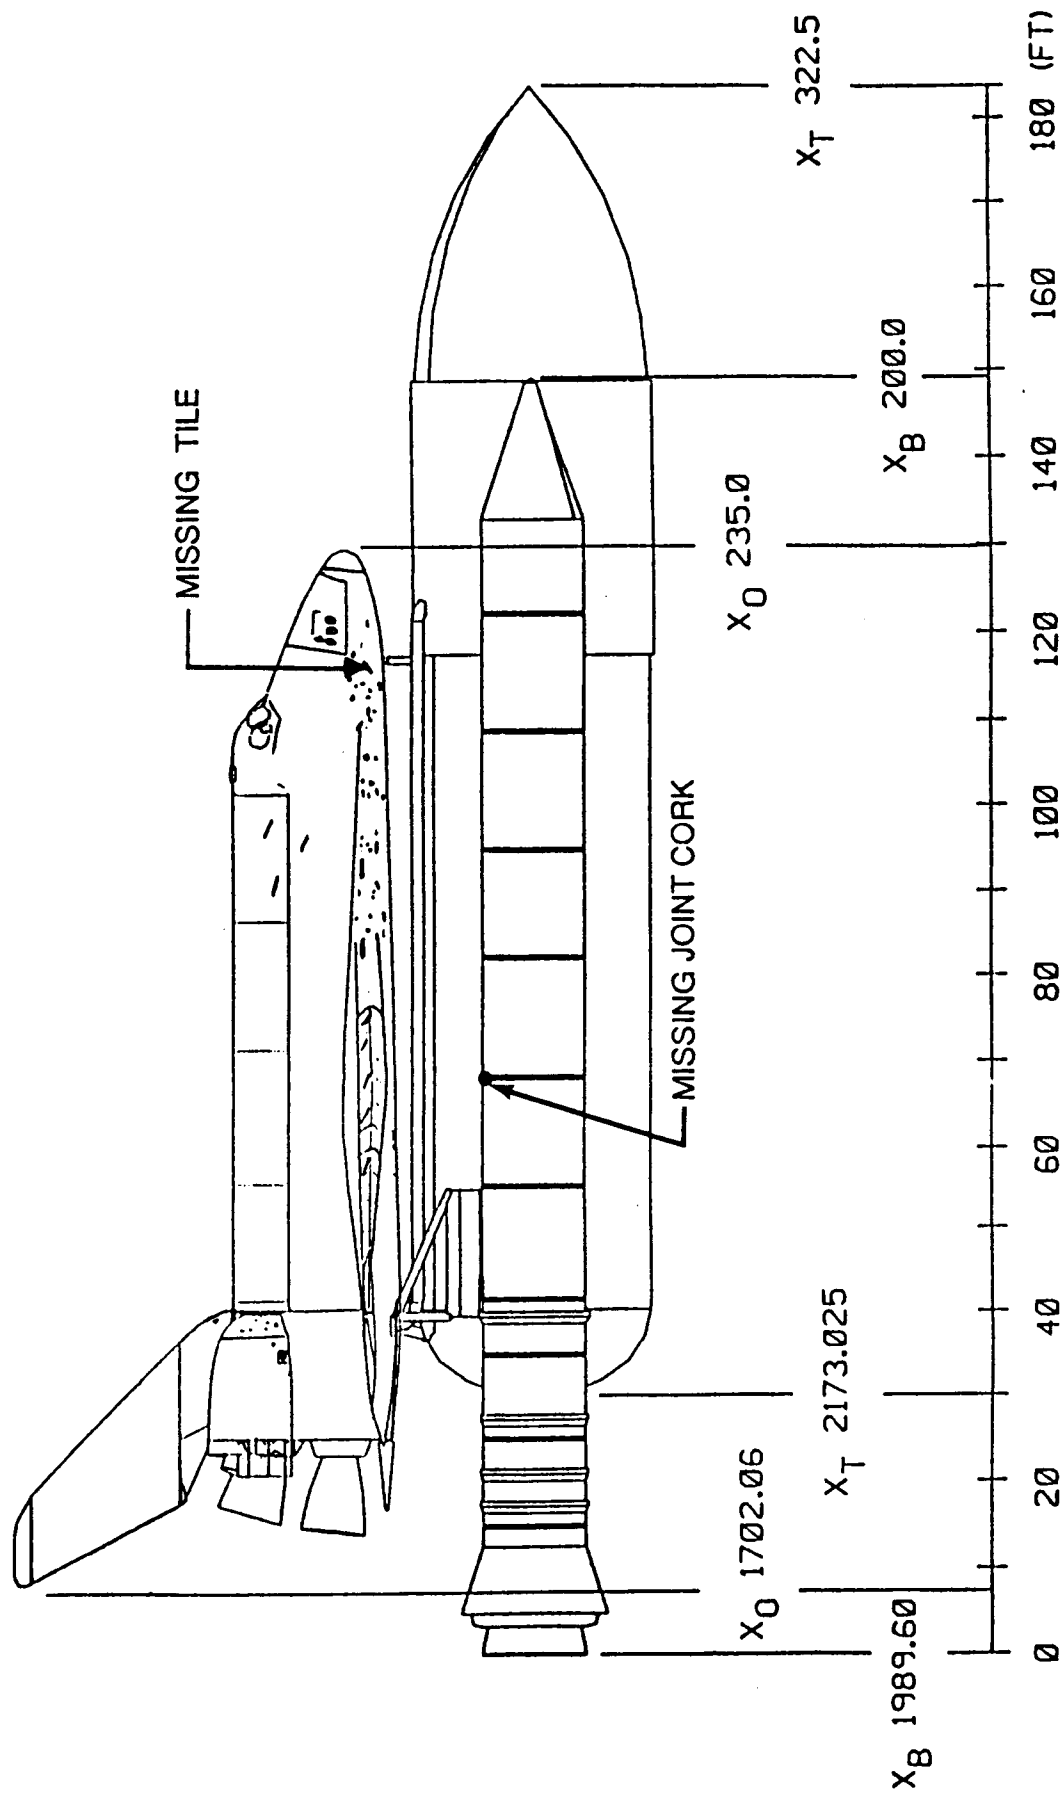
FIGURE 2-8
 ORBITER TPS DAMAGE REVIEW TEAM
 ORBITER TPS DAMAGE MAP PICTORIAL

The Orbiter damage sites and missing hardware are shown in Figures 2-8 and 2-9 depicting their relationship to the integrated Shuttle vehicle. Also, Figure 2-10 is included to depict the STS-27R major flight parameters.

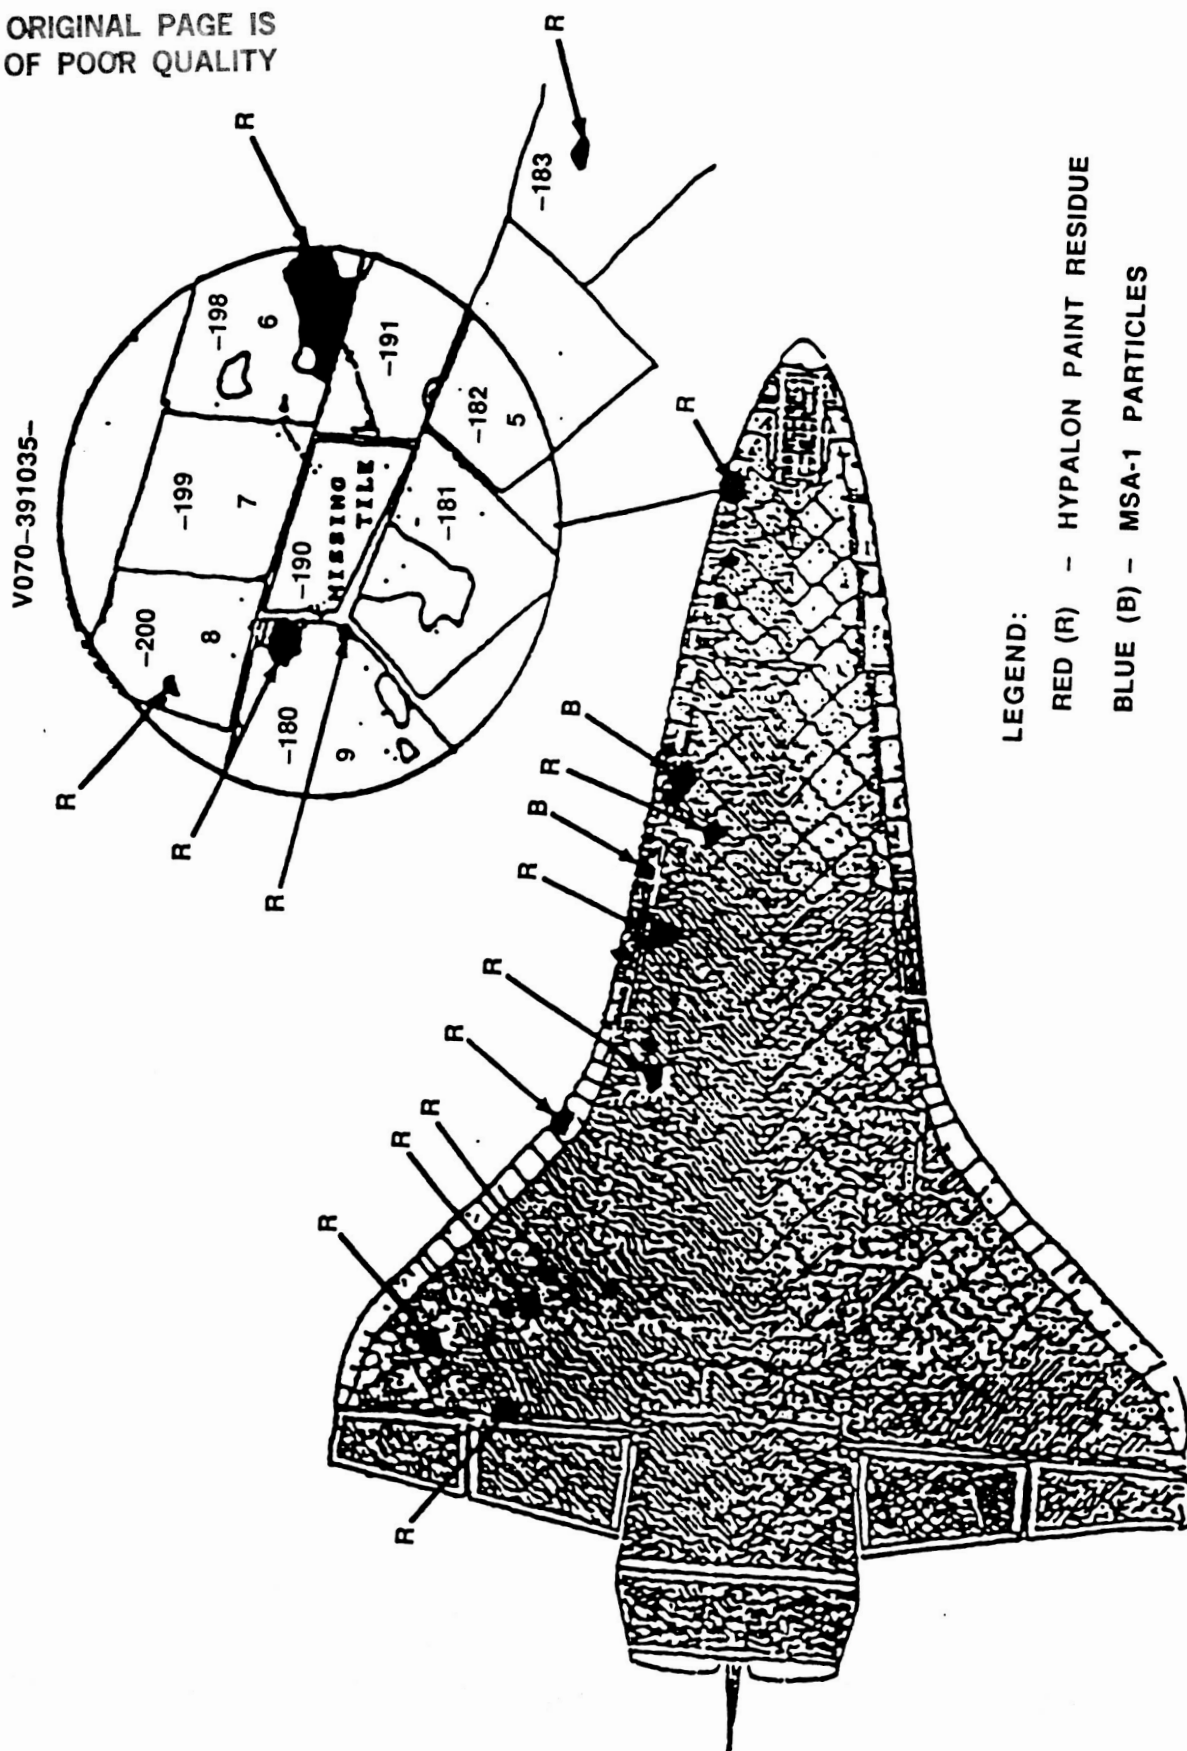
FIGURE 5-1 ORBITER LOCATIONS FOR
MATERIAL IDENTIFICATIONS

Table 5-1 and Figure 5-1 summarize the Orbiter locations where the debris/residue samples were found, the resulting material identifications, and the probable STS vehicle origins for the noted material. The most prevalent material found exhibited a paint signature. Sixteen of 38 TPS location samples showed either Hypalon paint or MSA-1 TPS traces. Although this signature, titanium in combination with aluminum, has other potential sources on the STS elements (Volume 6.a, Section 3.2.2.6), those other sources were either found intact during STS-27R post flight inspection or did not have a path or transport mechanism to the lower Orbiter surface. Therefore, the identified probable origin for the noted Hypalon paint debris is the SRB RH Nose Cap. Hypalon paint is applied to the SRB forward and aft assemblies primarily as moisture protection for the MSA-1 TPS. Since the aft assemblies are located so that debris transport to the Orbiter is not reasonable, and all the forward assembly but the Nose Cap was found essentially intact by post flight assessment, it has been concluded that the most probable origin was the SRB Nose Cap. Based on the STS-27R Orbiter sustaining most severe damage on its right side (Section 2), the source is further restricted to the SRB RH Nose Cap.

<u>WHERE FOUND</u>	<u>MATERIAL FOUND</u>	<u>PROBABLE ORIGIN</u>
W-1 CDR WINDOW	SILICA, RTV, SCOTCHGUARD	RCS NOZZLE COVERS
ORBITER LOWER SURFACE	HYPALON PAINT SIGNATURE	SRB NOSE CAP AREA
MISSING TILE AREA	MSA-1 ECCOSPHERES	SRB NOSE CAP AREA
RIGHT CHINE AREA	PHENOLIC BALLOONS (FROM MSA-1)	SRB NOSE CAP AREA
RIGHT GLOVE AREA	GREY-WHITE STREAKS	RECONDENSED SILICA FROM TILES
FORWARD OF MLGD	RTV, NOMEX FIBERS, SIP	TILE ADHESIVE, GAP FILLER
AFT OF MLGD		
RIGHT WING		
RCC PANEL	HYPALON PAINT SIGNATURE	SRB NOSE CAP AREA
RIGHT ORBITER WING		
RIGHT OMS POD	MSA-1 W/HYPALON TOPCOAT	SRB NOSE CAP AREA
	PDL FOAM W/FRL PAINT	ET NOSE CAP REPAIR OR "RABBIT EARS"
ORBITER MID-BODY	IRON FIBER (1.0MM X 0.05MM D)	UNKNOWN
MISSING TILE CAVITY	FILLER BAR, SIP, RTV	NORMAL MATERIAL
